## METALLOGRAPHIC EXAMINATION OF EPICOR-II LINERS

FROM THREE MILE ISLAND<sup>a</sup>

J. W. McConnell, Jr. and H. W. Spaletta  
P.O. Box 1625  
EG&G Idaho, Inc.  
Idaho Falls, Idaho 83415

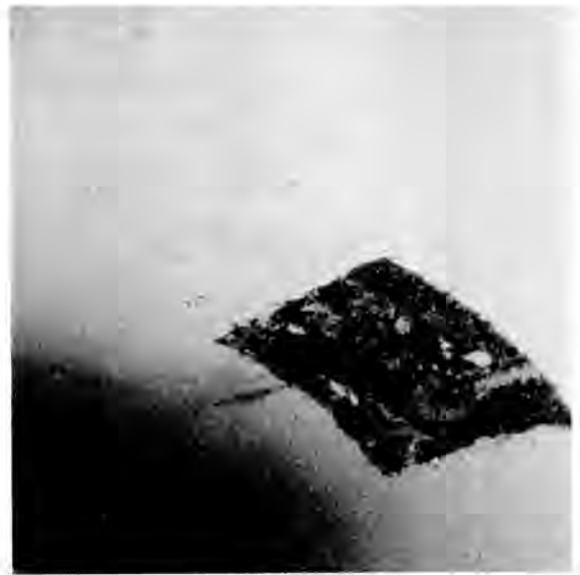
INEL 4 4331

In preparation for the liner integrity study, the ion-exchange media (resins) were transferred, using a vacuum system, to a new replacement liner. The empty liner then was decontaminated and hands-on visual and remote video examinations were conducted. After transferring the resins and removing the outlet headers, exterior and interior surfaces of the liners were examined visually and photographed (Fig. 2). Locations for metallurgical sectioning were marked on the exterior surfaces of the liners. Visual examination of the liners revealed that the exterior and interior base metal surfaces appeared sound as was previously reported by BCL in Ref. 5 and 6. It also was noted that the interior coatings were blistered, loose, and in some locations had spalled or chipped. There appeared to be more coating failures in liner PF-16 than -3 (see Fig. 2). The interior surface of liner PF-3 was coated with a

Fig. 2. Interior of liner PF-3 showing a dark area covered with rust and resin. The bottom of the liner contains residual resin. Streaks of rust from the manway area and numerous small coating blemishes are visible.

thin, rust-colored film. Both liners had bands of rust on the interior walls at the level corresponding to the top surface of the resin. Detailed descriptions of visual examinations of liners PF-3 and -16 are given in Ref. 4, 5, and 6.

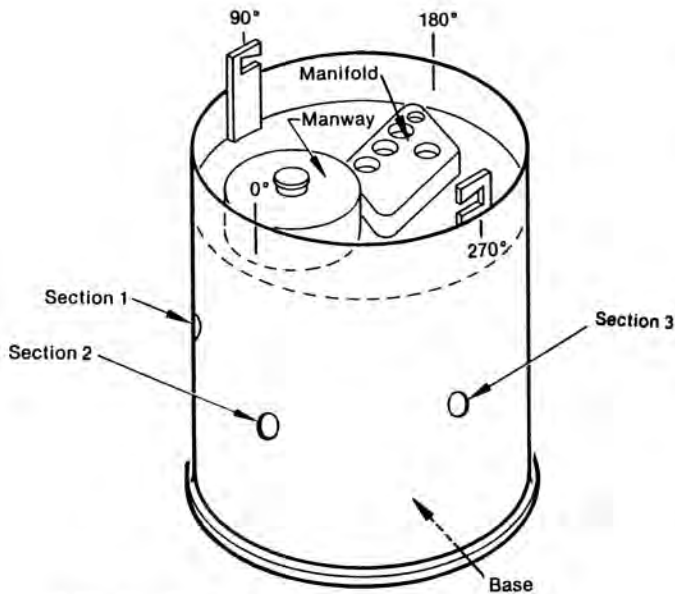
Locations of metallographic sections (shown in Figs. 3 and 4 for liners PF-3 and -16, respectively) were selected from areas that exhibited discontinuities in the internal surface coatings. Three sections were cut from PF-3, and four sections were removed from PF-16. One section from liner PF-3 was removed from the bare area. Sections were obtained from the cylindrical walls of the liners using a 3-in. diameter metal-cutting hole saw. A section was removed from liner PF-16 at the junction of the cylindrical wall and bottom of the liner, using a portable reciprocating saw. Sections 2 and 3 from PF-3 and Section 2 from PF-16 were removed from the area corresponding to the top surface of the resin bed.

Fig. 3. View of liner PF-3 showing locations where metal sections were removed.

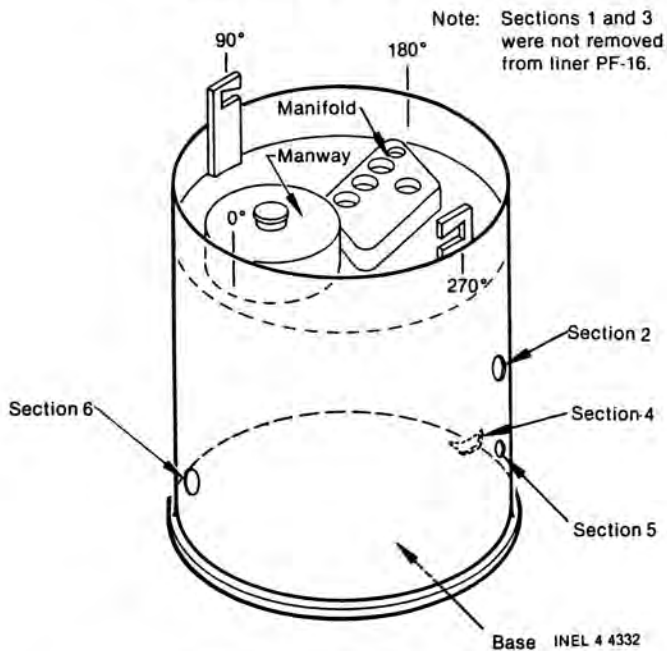
Fig. 4. View of liner PF-16 showing locations where metal sections were removed.

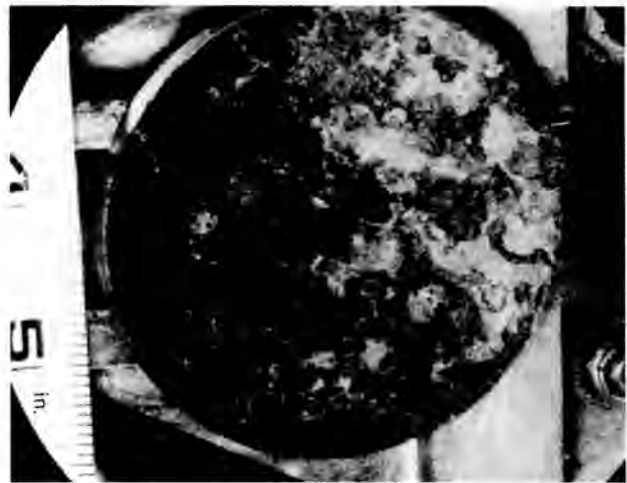
INEL 4 4421

**Section 1.** Section 1 was removed from the center of the bare grounding area for the conductivity probe, about 30 in. from the bottom of liner PF-3, 45° clockwise from the manway (see Fig. 3). The internal coating had been removed mechanically from that area of the liner. After decontamination by rinsing with mineralized water, contact readings of 35 R/h  $\beta$ - $\gamma$  were measured. Visual examination of the interior surface of the section revealed a heavy deposit of corrosion products and residual resin (Fig. 5). The high radiation readings required remote examination of this section in the TRA Hot Cells.

Fig. 5. Photograph of the interior surface of Section 1 from liner PF-3 showing a heavy deposit of corrosion products and residual resin.

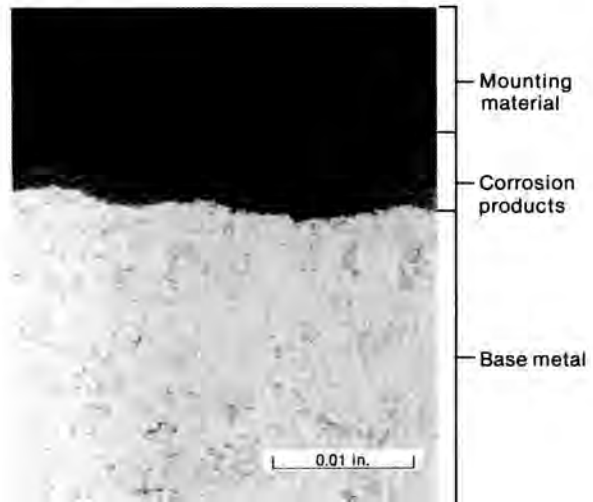
INEL 4 4348

**Section 1, Specimen 1-B--**Fig. 6 is a typical photomicrograph normal to the uniformly corroded

Fig. 6. Photomicrograph normal to the interior surface of Section 1 from liner PF-3 showing the uniformly corroded surface.

interior surface observed for Specimen 1-B. No evidence of pitting or pitting-type corrosion was evident. No interior coating was evident on the specimen, but the exterior coating was determined to be about 0.010-in. thick. The corrosion products partially spalled off during remote preparation of the specimen; therefore, accurate thickness measurements of corrosion products could not be made.

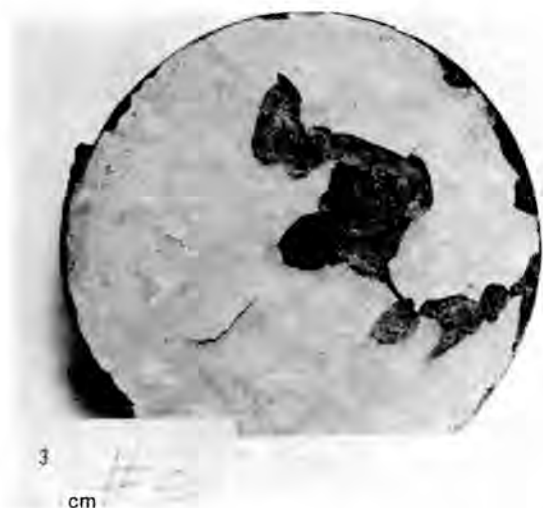
INEL 4 4357

**Section 3.** Section 3 was removed from the side-wall of liner PF-3, 90° counterclockwise from the manway, about 30-in. above the bottom of the liner (see Fig. 3). That elevation corresponded to the top surface of the resin. Visual examination of the interior surface of Section 3 revealed numerous coating blisters and areas where coating was not adhering to the base metal and had spalled (Fig. 7). Light corrosion products under an adherent coating and heavily corroded areas under blisters were observed (Fig. 8). The adherent coating is about 0.005-in. thick.

Fig. 7. Photograph of the interior surface of Section 3 from liner PF-3 showing coating blisters and areas where coating is missing.

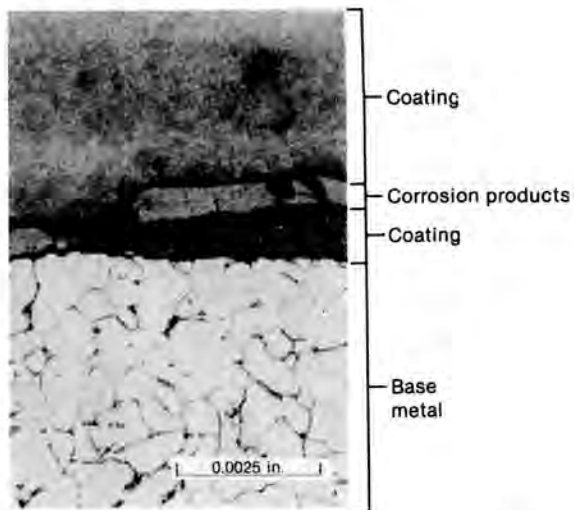
INEL 4 4334

Fig. 9. Photomicrograph normal to the exterior surface of Section 3 of liner PF-3 showing coating between the base metal and corrosion products.

**Section 3, Specimen 3-B**--The exterior surface of this specimen was examined at 100 magnification, and a heavy exterior phenolic coating of at least three layers was observed. Examination of the exterior surface at higher magnifications revealed corrosion products (about 0.0005-in. thick) between the coating and base metal, with a total coating thickness of about 0.010-in. Evidence that the coating had been applied over previously present corrosion products is indicated by layers of coating between the base metal and corrosion products (Fig. 9).

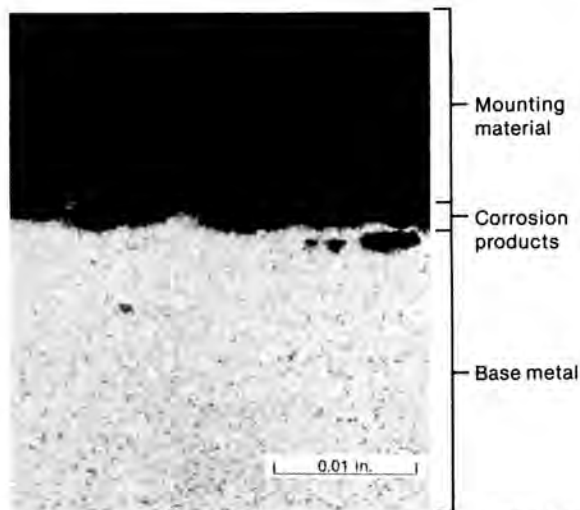
INEL 4 4352

Fig. 8. Photomicrograph normal to the interior surface of Section 3 from liner PF-3 showing corrosion products in an area where coating had spalled.

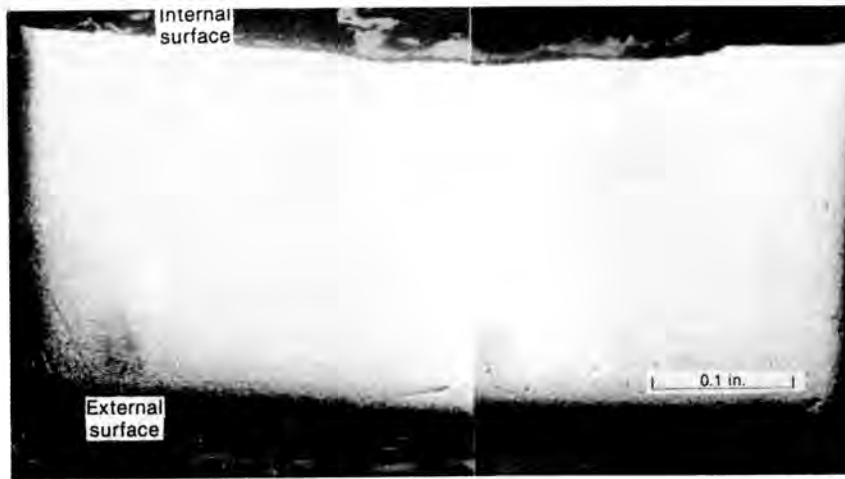
Visual examination of interior surfaces of specimens prepared from Section 1 revealed a horizontal groove-like indentation on the surface of the grounding area for the conductivity probe. The indentation on Specimen 1-B can be seen in Fig. 10. The difference between the thickness of the base metal in the corroded and uncorroded areas can be attributed to (a) corrosion, and (b) removal of some base metal

while mechanically removing the coating for the conductivity probe.

Fig. 10. Photomicrograph of Section 1, Specimen 1B (a vertical section from liner PF-3 normal to the grounding area for the conductivity probe) showing the horizontal depression on the internal surface.

An area on the interior surface of each liner is bare. That area was used as a ground for a conductivity probe liquid level detector. The bare area on liner PF-3 exhibited the minimum wall thickness for either liner. The metallurgical section removed from that area of PF-3 had a heavy buildup of corrosion products mixed with ion-exchange media on the surface. Although it is known that some base metal was removed mechanically during removal of the coating from the grounding area, that loss of metal could not be identified separately from the amount of metal lost by corrosion. In calculating the minimum lifetime of an EPICOR-II liner, it was assumed that all metal was lost by corrosion. It also was assumed that the corrosion rate was, and will continue to be, linear because the prefilter was a flowing system. That was a conservative assumption because, although the prefilter was a flowing system during use, approximately three years of storage provided stagnant conditions. Also, the bare area is small compared with the total interior area of the liner in contact with resin (about 3%); that resulted in a maximum amount of base metal removal through corrosion by concentrating the total corrosion capability of the liner contents on that small area. The minimum thickness of corroded base metal from Section 1 of liner PF-3 is subtracted from the maximum thickness of uncorroded base metal from Section 3 of liner PF-3. Mathematically, the lifetime of each prefilter is estimated at 50 years, based on the following calculations:

The area of maximum corrosion on liner PF-3 was determined to be the bare area on the inside surface where coating was intentionally removed. Corrosion in that area was uniform with no evidence of pitting or pitting-type corrosion. Comparing the minimum measured wall thickness in that corroded area with the measured uncorroded base metal thickness resulted in a calculated minimum lifetime for liner PF-3 of 50 years. That exceeds the required liner interim storage life of 13 years at INEL. The grounding area for the conductivity probe was not examined on liner PF-16, but it is assumed that corrosion in that area would be similar to the amount and type of the corrosion observed in liner PF-3.

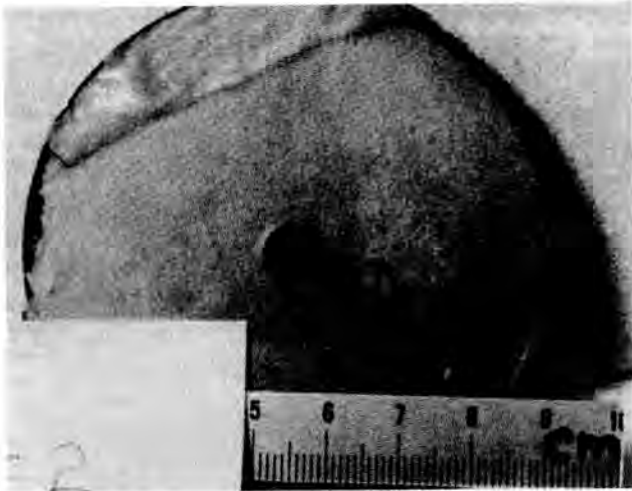
**Section 2.** Section 2 was removed from the sidewall of liner PF-16, about 110° counterclockwise from the manway, about 30 inches above the bottom, at the level of the top of the resin (see Fig. 4). Visual examination of the interior surface of Section 2 revealed a nearly defect free surface with one large blister in the coating along one edge of the Section (Fig. 11).

Fig. 11. Photograph of the interior surface of Section 2 from liner PF-16 showing a nearly defect-free coating.

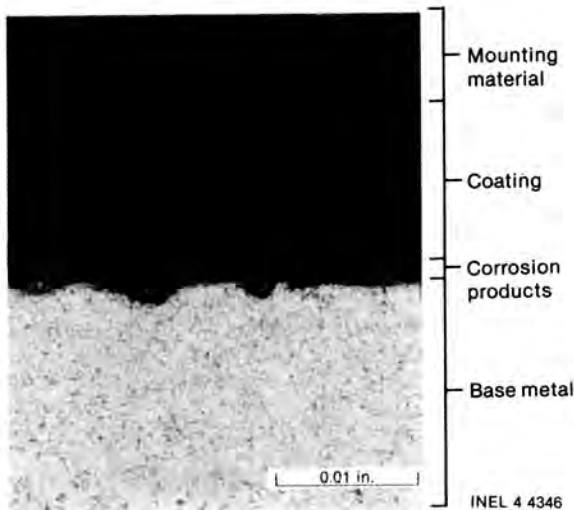
**Section 2, Specimen 1**--Examination of Specimen 1 revealed some corrosion products (about 0.001 to 0.002-in. thick) between the coating and base metal (Fig. 12). Total coating thickness was measured at about 0.012 inch. The coating generally adheres to the corrosion products, indicating that corrosion occurred before painting of the liner.

Fig. 12. Photomicrograph normal to the interior surface of Section 2 from liner PF-16 showing corrosion products between the coating and base metal.
