REMEDIAL ACTION AT THE NATIONAL GUARD ARMORY AND THE UNIVERSITY OF CHICAGO IN CHICAGO, ILLINOIS

N. J. Antonas, J. W. Darby, and C. R. Hickey
Bechtel National, Inc.
Oak Ridge, Tennessee 37830

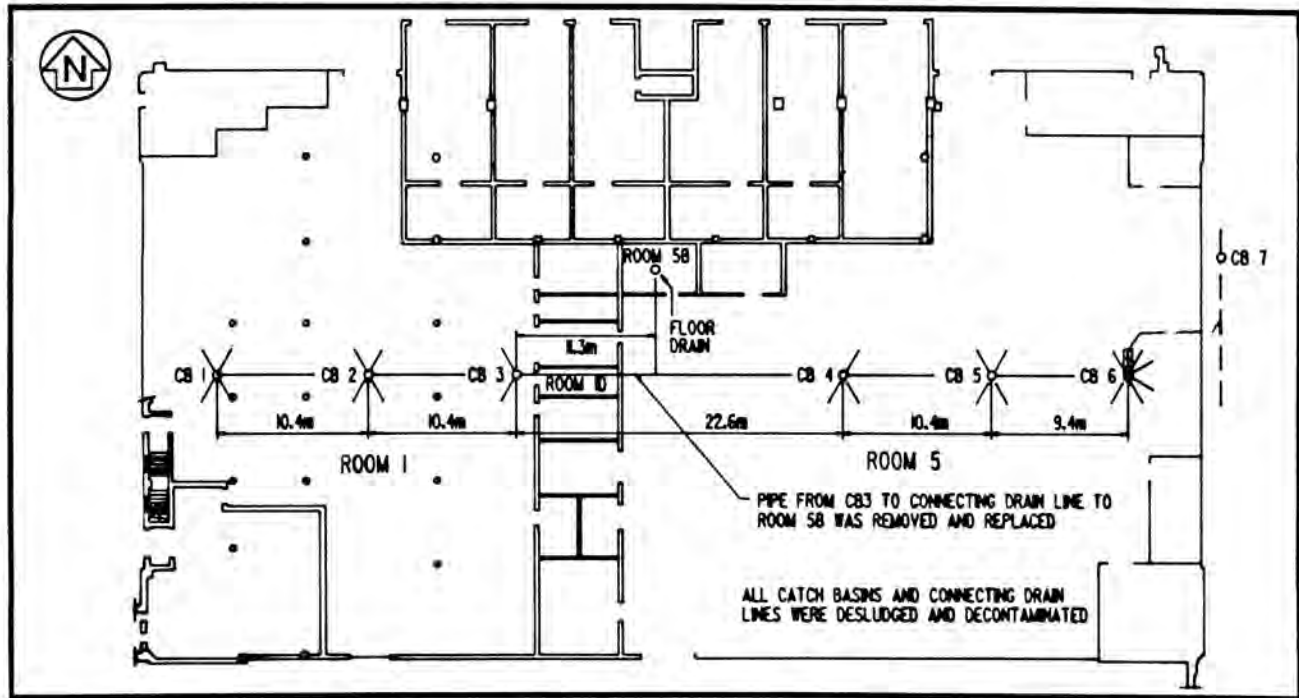
Fig. 2. The Catch Basin System on the First Floor of the South Headhouse (NGA).

The most challenging work was cleaning the six interior catch basins (see Fig. 2) located in the south end of the NGA. Sludge depths in each catch basin ranged from 0.5 to 1.0 m, with the flowline of the interconnecting drain line partially submerged in certain catch basins. The catch basins

were only 0.7-m in diameter, which made access difficult. Additionally, when the sludges were disturbed, the intense odors emitted could be detected throughout the lower portions of the south end of the NGA.

Workers were supplied with respiratory protection and protective clothing. Using spark-resistant hand tools, the sludges were removed from the basins. The interconnecting lines were flushed with a minimal amount of water to remove the sludges between the basins. This water was captured by plastic bags at the ends of the lines. A subsequent radiological scan indicated that portions of the line from basin 1 to basin 5, as well as basin 3, were radioactively contaminated. Most of the line (15.2-cm cast iron soil pipe) was successfully cleaned using a rotary cleaner with a 19-m drive extension. Several passes through portions of the line reduced surface contamination to less than guideline concentrations. Portions of the lines between basins 3 and 4 could not be cleaned with the rotary cleaner; there continued to be an area of high radioactivity in the line. By reviewing available drawings, it was determined that a junction existed from the interconnecting drain line to a 10-cm lateral line to Room 5 (see Fig. 2). This junction could not be successfully accessed for cleaning. Therefore, the junction and the portion of the main line from the junction to basin 3 was removed and replaced. The walls of basin 3 were sandblasted in an attempt to decontaminate the basin, but this was also unsuccessful. All the basins were constructed with bricks and mortar, and with basin 3, portions of the mortar had either deteriorated or were contaminated and could not be cleaned to DOE guidelines because they were inaccessible. Therefore, the entire basin was removed and replaced. Subsurface soils around the lines and beneath and around basin 3 were sampled and analyzed for radioactive contamination. All analytical results were below DOE guidelines.

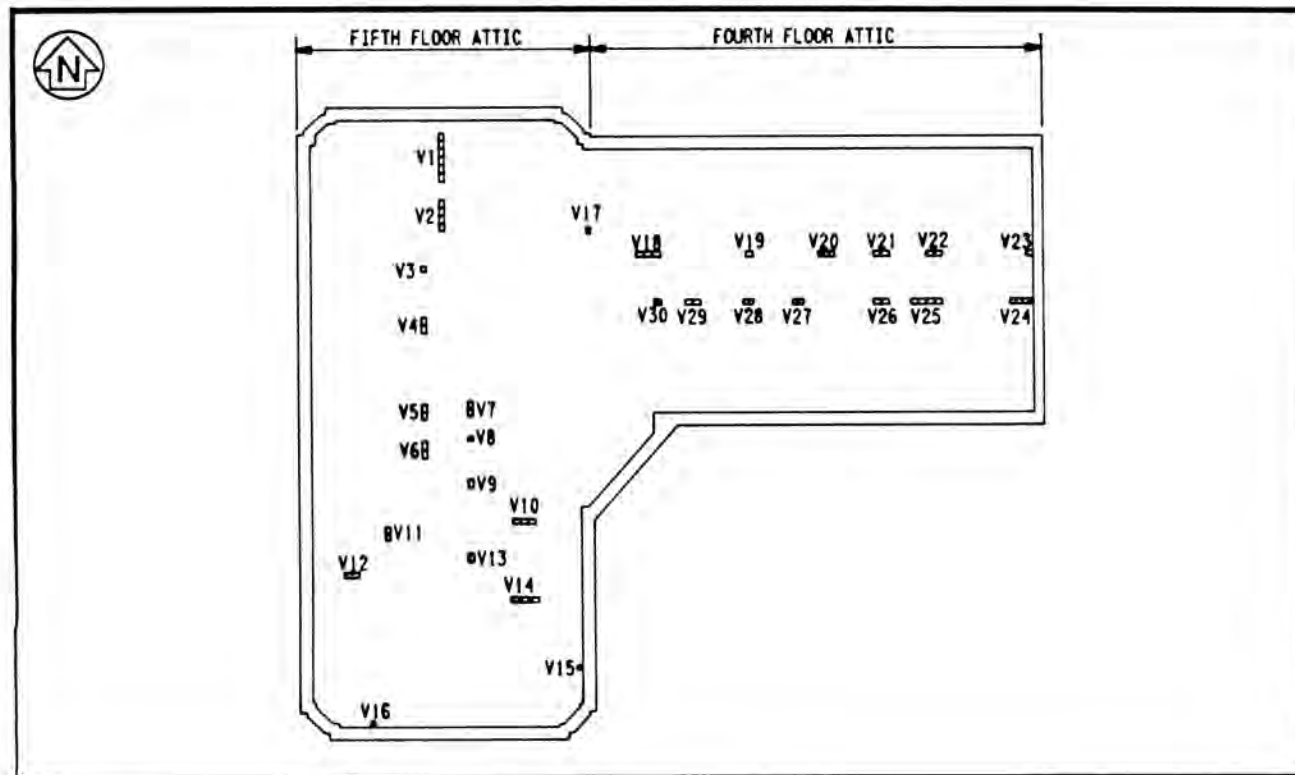
Fig. 3. Attic Plans Showing Chase Locations.

The major focus of the remedial action was the decontamination of the exhaust system, which consisted of three main segments: the vertical risers in the walls, the attic ductwork, and the chimneys (see Fig. 3).

The system was then scanned for radioactive contamination. This survey indicated that four risers were contaminated. The remedial action continued with the removal of the risers and the associated ductwork. Access to the risers was provided by removing one face from each of the chases. The flue liners were removed in segments where possible. The tile material was then moved to a controlled area where the segments were reduced to smaller pieces.

The survey also identified eight contaminated chimney flue liners. To avoid demolishing the stonework, the liners were removed and the voided space partially plugged with concrete.

The University's plans for the facility were such that it was not necessary to replace the risers or ductwork that were removed. The chase walls were reconstructed and the wall and ceiling surfaces finished to match the surrounding areas.
