SURVEILLANCE AND MAINTENANCE OF THE WEST VALLEY STATE LICENSED LOW-LEVEL RADIOACTIVE WASTE DISPOSAL AREA 1983-1987

D. B. Anderson
New York State Energy Research
and Development Authority
Albany, New York 12223

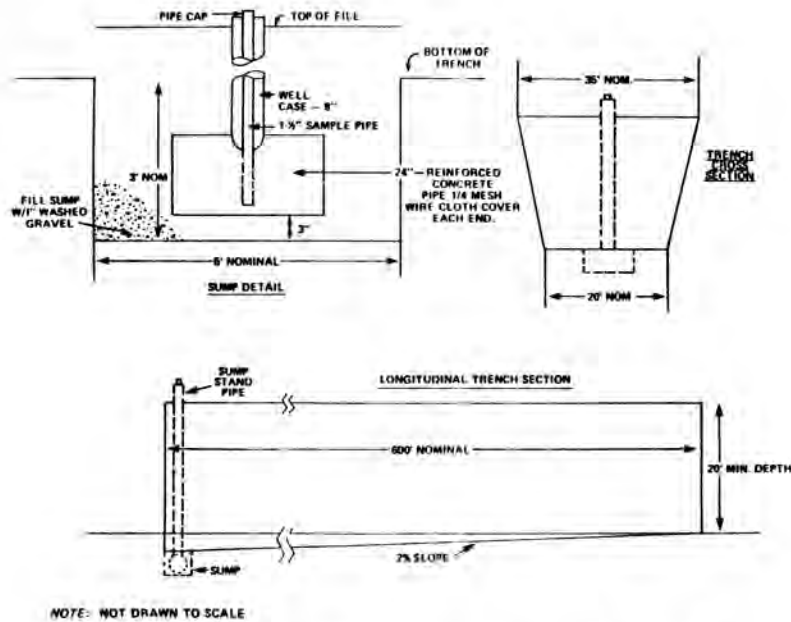
Fig. 4. Typical West Valley Trench Construction Details.

(1) topsoil and coarse surface materials were removed, (2) separation distance between trenches was increased to 3m (10 feet), (3) trench floors were sloped from previously disposed wastes, (4) trenches were covered with individual caps, and (5) cap thickness was increased to 2.4m (8 feet) (Fig. 4).

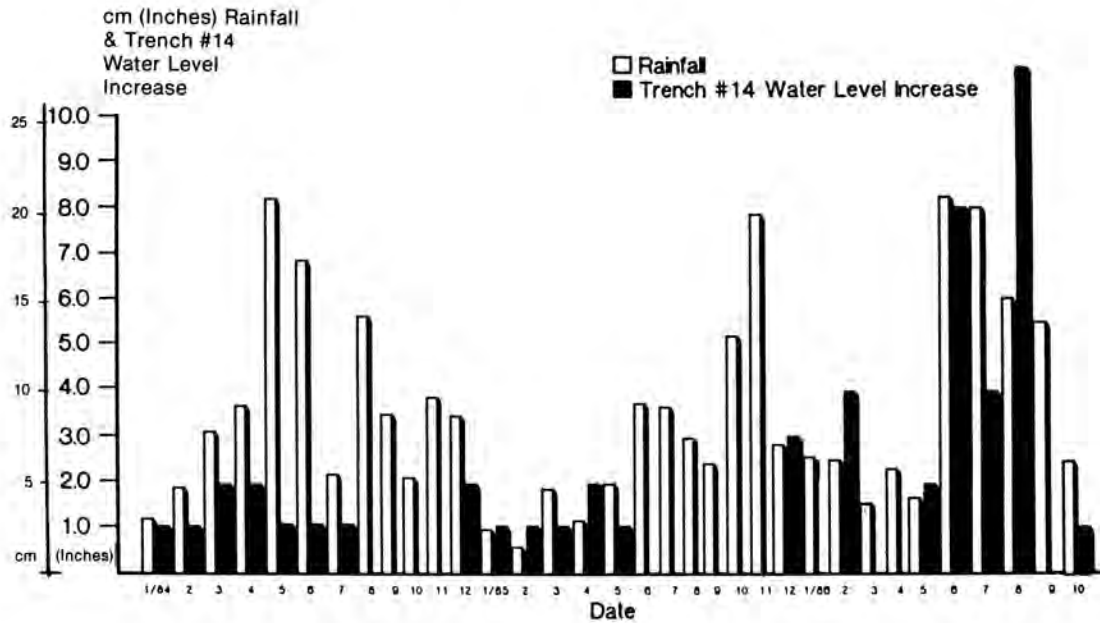
Fig. 5. Trench 14 Performance 1984-1986.

Of those trenches showing water level increases since the 1980-81 pumpdown, Trench 14 had by far exhibited the most significant increase. Between 1981 and 1986, its water level increased at a fairly moderate rate of 2.5-5cm (1-2 inches) per month; however, in June 1986, a 20cm (8 inch) increase was measured. In July, the increase was 10cm (4 inches), and in August, a 28cm (11 inch) increase was recorded.

A review of trench sump water level and precipitation data indicated a strong correlation between rainfall and increased water levels in the Trench (Fig. 5). Initially suspecting trench cover failure, the cover of Trench 14 and the drainage ditch between Trenches 13 and 14 were inspected for defects (potholes, desiccation cracking, etc.). No visible defects could be found by Energy Authority staff. The Energy Authority concluded that, although cap failure could not be completely ruled out, there was a strong possibility that water was entering the trench through a layer of weathered silty till west of Trench 14 or that water was being conducted in via a permeable unit located in that area. It is noted that during the spring and summer of 1986 there was an unusual amount of precipitation during frequent severe thunderstorms and, at times, standing water was observed in the field west of the trench. The Energy Authority took prompt action to improve the drainage in the area and the rate of infiltration slowed dramatically despite continued wet weather. This fact led the Energy Authority to focus more attention on the field west of the trench.

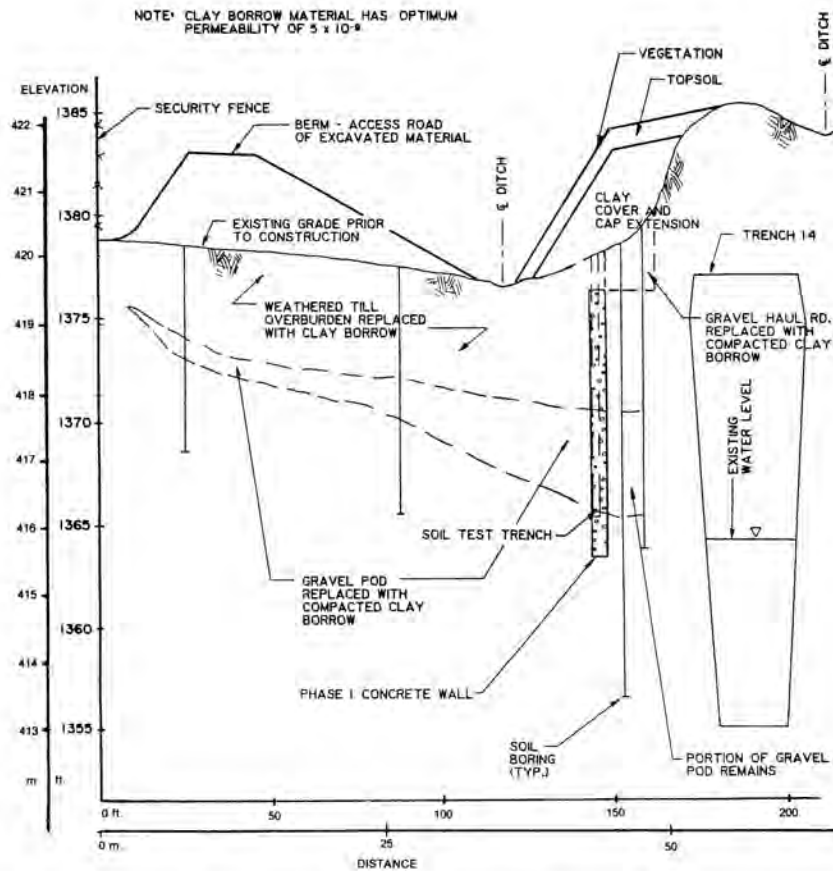
Fig. 6. Trench 14 Maintenance Project.

Although there was some historical documentation suggesting the earlier presence of a sand/gravel unit near the surface, the discovery of this unit was unexpected. The unit ran along the side of the trench for some 30m (100 feet), reaching a maximum depth of about 4m (13.5 feet) and 1.5m (5 feet) in thickness. It extended toward the west a distance of some 50m (165 feet), and contained some 1050m³ (1400 yd.³) of sand/gravel. The Energy Authority concluded that the sand/gravel unit had the potential to compromise the integrity of the SDA, despite the apparent effectiveness of the drainage improvements. Of most concern was the observation that the lowest extent of the permeable unit within 6m (20 feet) of the trench was very close to or at the existing leachate level in the trench. If the sand/gravel unit did intersect Trench 14 at a depth of 4m (13.5 feet), any subsequent trench water level increase could have resulted in contamination of the sand/gravel unit with trench leachate. This would have made the subsequent remediation project (which involved excavation in that material) more difficult. Radiological surveys of the soil borings indicated that the unit was not contaminated at the time of the investigation; however, the Energy Authority could not be confident that it would remain clean indefinitely. Immediate action was taken to reduce trench water level and avoid any potential water inflow (or outflow) through the sand/gravel unit.

To provide additional protection against water entering the trench, and to create a wall against which the planned extensive excavation work in the sand/gravel unit could be conducted, a subsurface concrete wall was installed immediately west of Trench 14 (Fig. 6). The wall was started and completed on February 17, 1987. It was a minimum of 1.2m (4 feet) thick, 40m (130 feet) in length, and contained some 320m^3 (420yd^3) of concrete.

In the summer of 1987, the Energy Authority completed the remainder of the remedial action project. The effort consisted of removing the entire sand/gravel unit west of the concrete wall, replacing it with compacted silty/till clay from a nearby borrow area, grading the affected area for more effective drainage and establishing a vegetation cover. By the end of the 1987 working season, the project had been essentially completed. Only some cleanup work remains. As of the writing of this paper, some five months have lapsed without a significant water level increase in Trench 14. The total level increase in the past 18 months (since August, 1976) was 18cm (7 inches), well below the previous rate. The Energy Authority continues to closely monitor the trench to determine the success of this effort.
