ACCELERATED CLEAN-UP AT THE HANFORD SITE

J.M. Frain and W.L. Johnson
Westinghouse Hanford Company

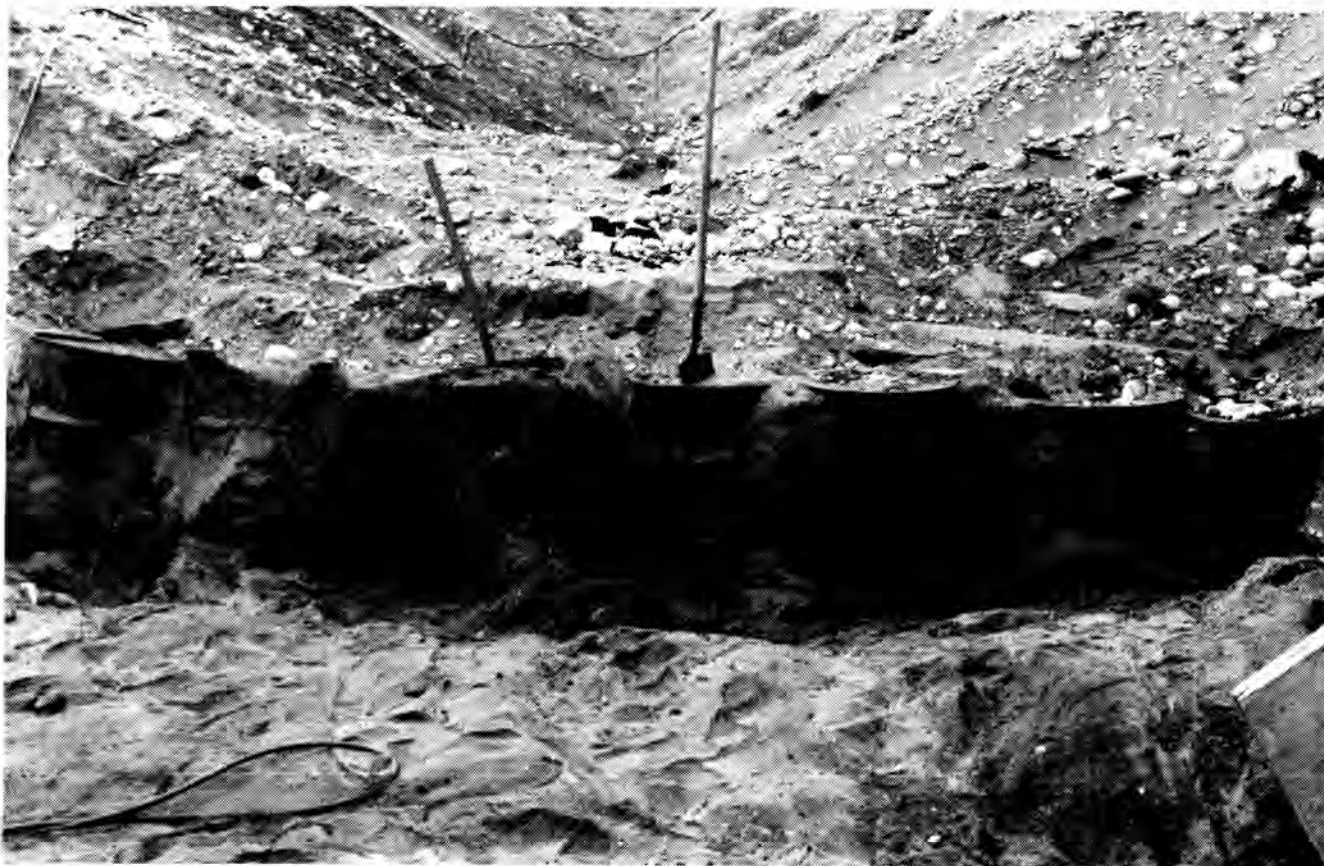
Fig. 2. Side view of drums as found in the trench.

Initially, the excavation revealed a variety of debris covered by 1.2 m (4 ft) of backfill. The debris included such items as, empty waste drums, a wheel barrow, construction debris (corrugated siding), breached bags of ammonium nitrate fertilizer, unidentified white powders, and several lead bricks. Since the historical information stated that there was 1.2 m (4 ft) of backfill over the drums, and did not mention a large volume of debris, it was assumed that the anomalies seen in the ground-penetrating radar data were drums, not debris. The large volume of debris found was unexpected. The drums were found on either side of the debris, with a minimum of 2.4 m (8 ft) of backfill. Figure 2 shows a side view of the drums found in the bottom of the west end of the trench, and how they were approached. Note that the center drums did not contain solvents. Over the years, the tops had collapsed and filled with the overlying sand.

Drums in the western end of the trench were fairly well preserved, and approximately 6,050 L (1,600 gal) of solvents were recovered. Drums in the eastern end of the trench were severely corroded and only parts of the drums remained. Figure 3 depicts the three sections of the trench (this figure is not to scale).

A nonsparking bronze spike, welded to the backhoe bucket, was used to remotely punch a hole through each drum. If liquid was found, it was tested with a field test kit and subsequently pumped into a new drum. Preliminary sampling using the Haztech Hazcat kit (a trademark of Sensidyne) provided an initial designation of the chemical compound and its compatibility with other materials found in the trench. This information was used to develop an estimate of the volume of hexone and/or kerosene in the trench, to calculate a conservative estimate of the volume which could have leaked, and to assist in waste segregation. From this sampling, it was estimated that 2,650 L (700 gal) of hexone (ketone) and 3,400 L (900 gal) of kerosene were recovered from the trench.

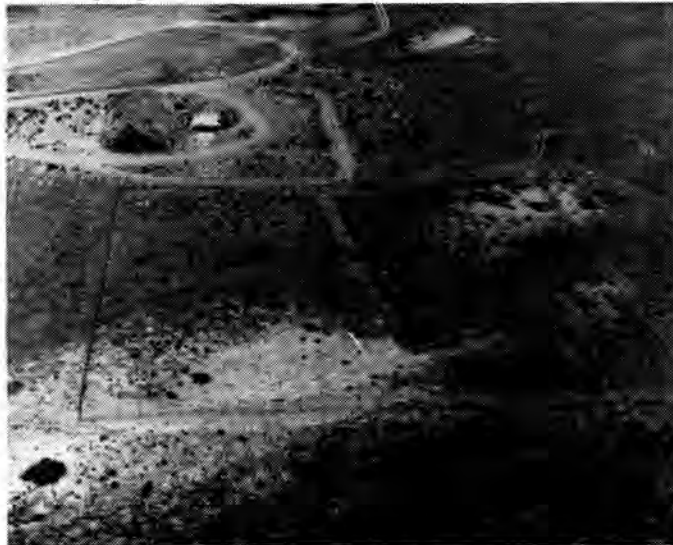
Fig. 4. Burial ground prior to excavation.

All waste recovered from the site was disposed according to the applicable state and federal requirements. Figure 4 shows the site prior to beginning excavation. Figure 5 shows the site as excavation work was being completed.
