THE PINELLAS PLANT RCRA FACILITY INVESTIGATION - A CASE STUDY

Richard Kilbury and Berg Keshian
Roy F. Weston, Inc.
Albuquerque, NM

ABSTRACT

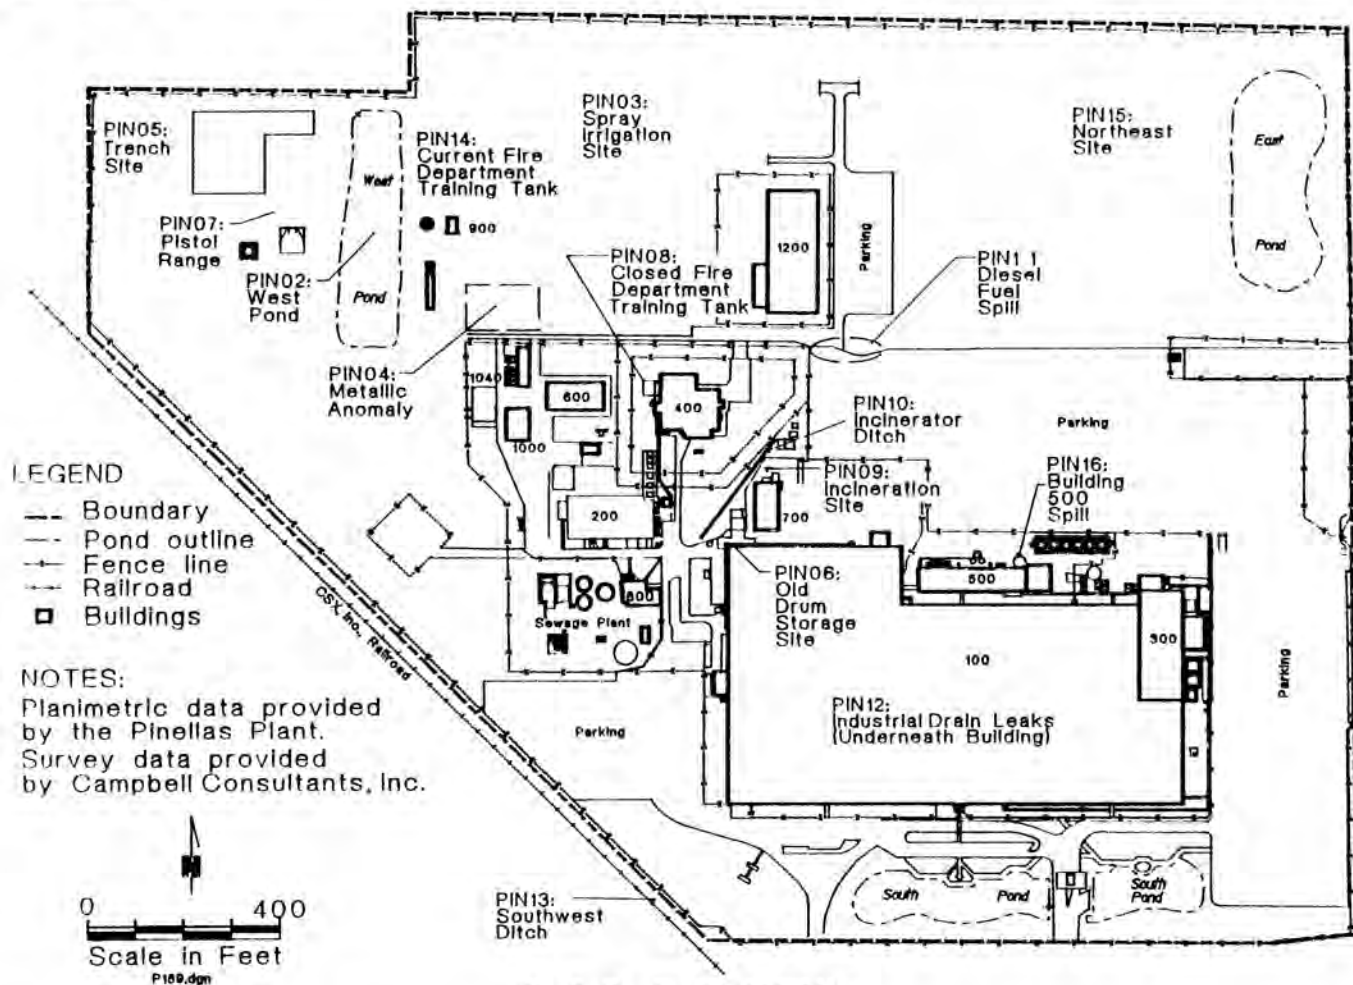
Fig. 2. Pinellas Plant SWMUs.

The West Pond is a man-made surface water impoundment that received pH-neutralized industrial effluent and tertiary treated sanitary sewage from 1972 to 1982 (Fig. 2). Surface water, sediment, soil, and groundwater samples collected during the RFI showed that results for surface water samples were well below Florida Department of Regulation (FDER) ecological standards and current Safe Drinking Water Act (SDWA) and FDER Maximum Contaminant Levels (MCLs). Dissolved oxygen profiles measured in the pond during the RFI indicated that the pond is capable of supporting healthy aquatic biota. Groundwater sample results for four wells installed around the perimeter of the pond were below SDWA and FDER MCLs. For the past few years, osprey have nested at the Pinellas Plant, are observed feeding on fish at the West Pond, and have successfully produced offspring. DOE recommended that no further action be required at the West Pond.

The former Pistol Range (PIN07) was located west of the West Pond in the northern section of the Pinellas Plant (Fig. 2). The Pistol Range consisted of a covered firing area with an earthen backstop behind the target area, and operated from 1972 to 1985 as the primary location for target practice for plant guards. The backstop material was removed and dis-

RFI results confirmed elevated levels of lead measured in surface soil samples. EP Toxicity leachate results ranged up to 8,030 $\mu\text{g/L}$; current Toxic Characteristic Leaching Procedure (TCLP) standards are expected to be elevated. Metal results for groundwater were below SDWA MCLs. Previous results and RFI results indicate that the extent of contamination at PIN07 is generally confined to the former Pistol Range area. The debris piles and former backstop area did not reveal levels of contaminants that exceed standards or are of concern. The DOE recommended that a CMS be completed for the Pistol Range that will focus on shallow surface soil contamination within the area of the former Pistol Range. The goal is to remove lead from the area before this metal leaches to groundwater. Because corrective action at the Pistol Range is likely to consist of the removal and disposal of a relatively small volume of surface soil, the DOE anticipates that this action can be implemented as an interim remedial action.

The Old Drum Storage Site and the Building 100 drain leaks are presented together because contaminated PIN06 and PIN12 wells were found in the same vicinity at the northern perimeter of Building 100 (Fig. 2). The Old Drum Storage Site was located near the northwest corner of Building 100 at the Pinellas Plant. An 18-by-18-ft concrete storage pad, equipped with a drain and containment system, was present for an unknown period of time. The pad was used to store hazardous waste, including methylene chloride, ignitable liquids, arsenic, and calcium chromate solids. The drum storage pad was steam-cleaned and removed in October 1983. PIN12 consists of the liquid waste system serving Building 100 at the Pinellas Plant that is comprised of health physics, chemical, sanitary, and storm drainage systems. Over the years, as a result of pipe corrosion, a number of leaks may have occurred in these systems.
