CONSTRUCTION AND OPERATION OF A RCRA-TYPE SURFACE IMPOUNDMENT AT A MIXED WASTE FACILITY

Galen H. "Butch" Freeman and Sheryl L. Hodges
Jacobs Engineering Group, Inc.

ABSTRACT

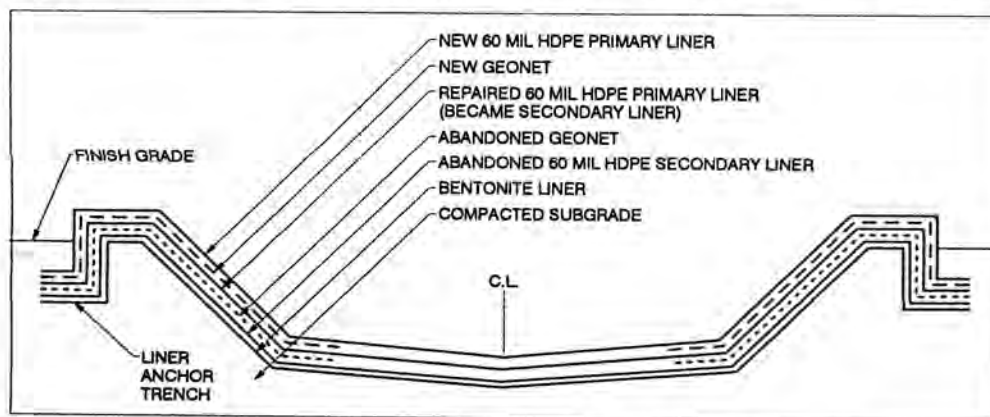
Fig. 2. Weldon Spring quarry equalization basin liner configuration.

Cost, schedule, and reliability were all factors contributing to the decision to proceed with the following approach to repair of the equalization basin (see Fig. 2).

1. Abandon the existing lower liner in place; cut through the upper liner at locations of high tension as required to relieve stress; patch cut areas as required with new material.
2. Remove a section of the upper liner immediately above the leachate collection sump and associated section along with drainage net, and collection piping. Fabricate a new collection sump section.
3. Install the newly fabricated sump section over the existing lower liner, welding seams as appropriate (double wedge hot shoe welding for joining panels or extrusion welding in other areas, e.g., at pipe boots); replace collection piping and drain media; install new geonet and liner on top of the old primary upper liner (now serving as the lower secondary liner); anchor new liner and drainage net in existing anchor trench.

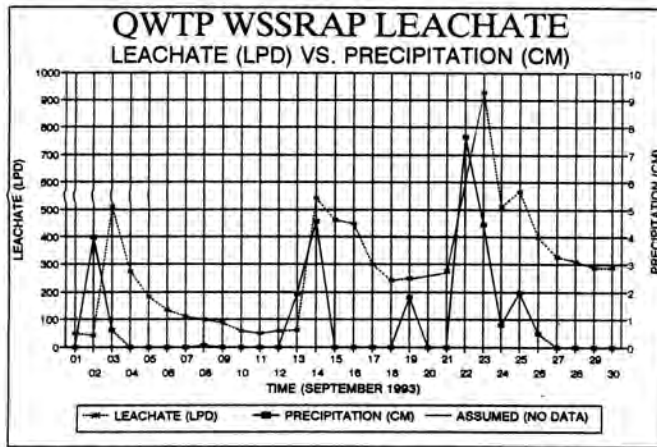
Fig. 3. Leachate flow rate vs. precipitation quarry equalization basin.

Conclusions from information gathered to date indicate that in general, precipitation and resulting infiltration contribute most of the leachate generated each month (see Fig. 3). A chemical tracer test using NaCl (stock salt) was used to examine potential seepage between the liners via the liner anchor trench along the basin's southeast edge. This test confirmed that seepage from outside the basin was entering the liner system. The influent and overflow piping for the equalization basin were excavated and seepage along the pipe bedding was observed. To correct this, an interceptor trench was constructed, and the trench's sump is continually pumped to reduce seepage entering the leachate sump. However, after significant precipitation events, substantial increases in leachate volume are observed. Therefore, drainage improvements are being developed to control surface water infiltration from the area surrounding the basin.

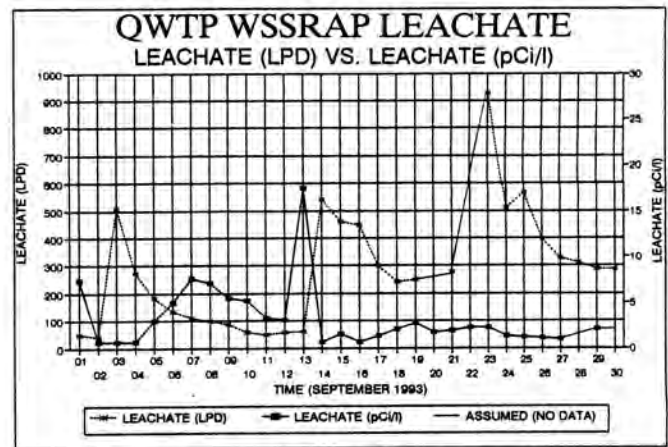
Fig. 4. Leachate flow rate vs. leachate U (total) concentration quarry equalization basin.

Following a precipitation event, leachate flow increases as would be expected, and leachate [U] has been observed to decrease concurrently as illustrated in Fig. 4. In part, this

relationship may be attributed to dilution from storm water inflow. Basin water levels do not appear to have correlated significantly with increased leachate flow (see Fig. 5). No apparent correlation between basin [U] and leachate [U] has been noted during ongoing observation, although it would be expected.

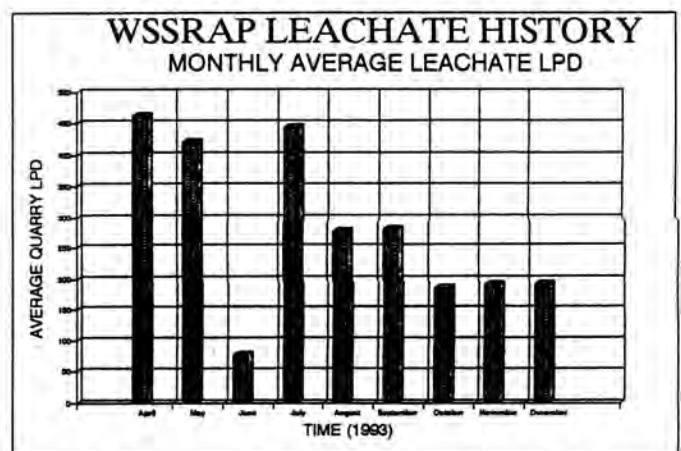
Fig. 6. Historic monthly flow rate quarry equalization basin.

The daily leachate data is averaged weekly and reported monthly to the MDNR. Possible seasonal variations in leachate flow are trended as illustrated in Fig. 6.
