## METALLOGRAPHIC EXAMINATION OF EPICOR-II LINERS

FROM THREE MILE ISLAND<sup>a</sup>

J. W. McConnell, Jr. and H. W. Spaletta  
P.O. Box 1625  
EG&G Idaho, Inc.  
Idaho Falls, Idaho 83415

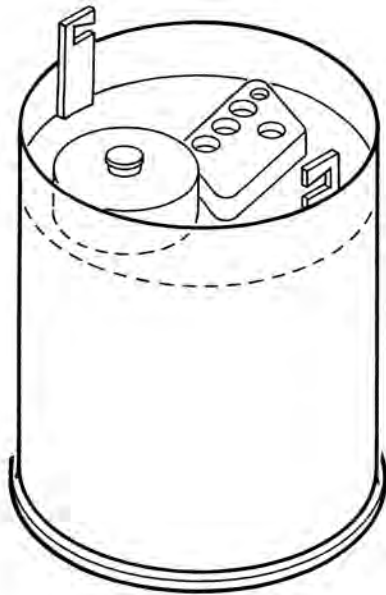
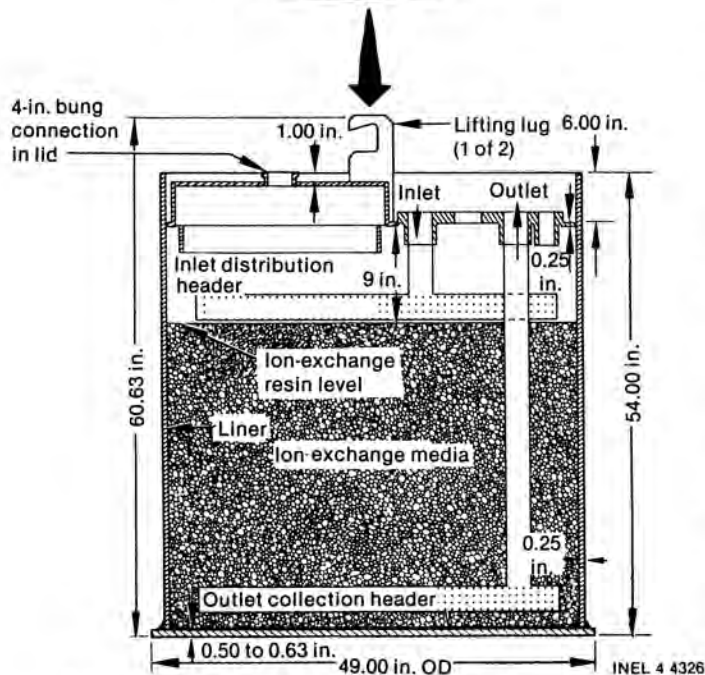
Fig. 1. Schematic (isometric and full section) of an EPICOR-II prefilter.

EPICOR-II liners are cylinders that are 49-in. in diameter by 54-ft in height. Their walls and tops are 1/4-in. thick and bottoms are 1/2 to 5/8-in. thick (Fig. 1). The liners are of welded construction using ASTM Type A-36 carbon steel. The internal and external surfaces are painted with Phenoline<sup>b</sup> 368 coating. A localized area of coating about 8 x 2 in. was removed from the interior surface of each liner. That bare area was used as the grounding point for a conductivity probe for measuring water level in the liner. Each liner contains about 30 ft<sup>3</sup> of ion-exchange media. Liner PF-16 contained both organic ion-exchange resin and inorganic zeolite. Liner PF-3 contained only organic resin. A perforated four-branch influent manifold distributed contaminated water over the exchanger bed, while the effluent was drawn off the liner bottom through a porous multibranch return manifold. Both manifolds are piped to a manifold plate on top of the liner. A vent port and adapters for liquid-level detectors also are located on the manifold plate. A manway is located beside the manifold plate on the liner top. Exchange media were loaded into the liner through
