SURVEILLANCE AND MAINTENANCE OF THE WEST VALLEY STATE LICENSED LOW-LEVEL RADIOACTIVE WASTE DISPOSAL AREA 1983-1987

D. B. Anderson
New York State Energy Research
and Development Authority
Albany, New York 12223

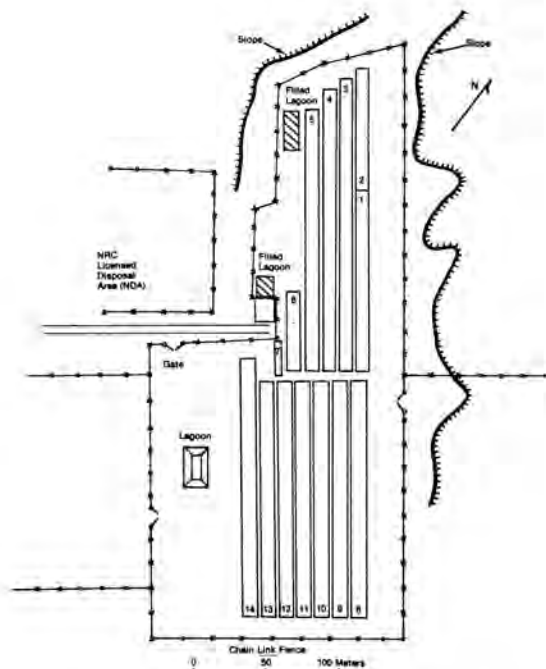
Fig. 3. State Licensed Disposal Area (SDA).

The SDA occupies approximately 15 acres southeast of the reprocessing plant and is adjacent to the NRC-licensed disposal area (NDA). The NDA is currently in the possession of DOE for use by the WVDP. The SDA consists of two distinct sets of parallel trenches, identified as north and south disposal areas (Fig. 3).
