PHOSPHATE/SULFATE WASTE GROUT CAMPAIGN REPORT

M. W. Cline, A. R. Tedeschi and A. K. Yoakum
Westinghouse Hanford Company

The grout facility, which is managed by Westinghouse Hanford Company for the Department of Energy, processed one million gal of low-level radioactive waste into a final-disposal form. The Phosphate/Sulfate Waste (PSW) campaign was initiated August 30, 1988, as part of Westinghouse Hanford Company's defense waste disposal program. The facility was restarted in April 1989 and again in June 1989 to complete processing 1,001,000 gal. Several deficiencies were identified during this campaign. The final operation of the facility in June 1989 successfully demonstrated the ability of both the Dry Materials Facility (DMF) and the Transportable Grout Equipment (TGE) facility to support conversion of low-level liquid wastes to grout slurry and subsequent transfer to a near-surface concrete vault for solidification and disposal.

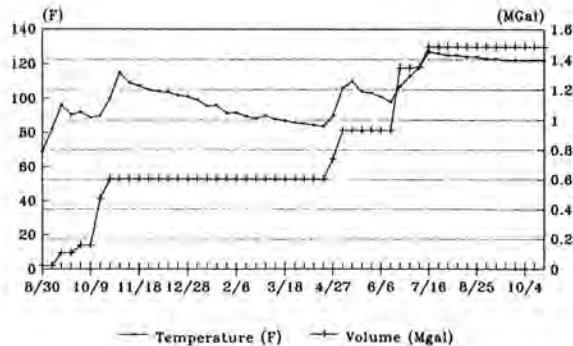
Fig. 2. Average Grout Curing Temperature.

The average grout temperature in the vault along with grout levels is presented in Fig. 2. The average temperature is a computer generate average of the temperatures measured by the thermocouples submerged within the grout.

The computer uses a grout level indicated by the level probes for this average.

The average temperature is useful in trending the total grout mass with respect to the process operation, as reflected in the changing vault grout level. The actual temperature is higher due to approximately two ft of ambient air above the grout surface, which is averaged in to the overall grout temperature by the computer. The actual grout temperature initiated at 82°F and reached a maximum of 149°F. All temperature data was logged by the computer data logging system at TGE and has been downloaded and archived. The ambient air temperature above the grout surface is approximately 80°F to 85°F while the grout temperatures are in the range of 95°F to 120°F.

The grout tends to rise in temperature on initial curing and then begins to cool off as curing progresses.
