## EXPERIENCE OF THE SURVEYOR™ MOBILE ROBOT AT NINE MILE POINT

B. G. Kniazewycz  
KLM Technologies, Inc.  
2700 Ygnacio Valley Road, Suite 160  
Walnut Creek, California 94598-3454

T. L. Irving  
Niagara Mohawk Power Corporation  
Nine Mile Point - Unit 1  
P.O. Box 32  
Lycoming, N.Y. 13093

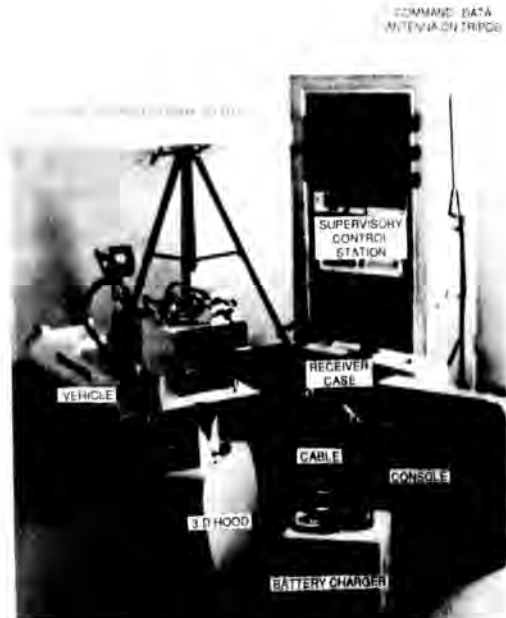
Fig. 1. Surveyor™ Mobile Surveillance System.

The Surveyor™ Mobile Surveillance System shown in Fig. 1 provides remote, wireless operation in hazardous environments. The system is designed to meet specific guidelines to minimize occupational

exposure to hazardous environments and to provide plant operations with the information to support plant performance. Sensors, including radiation, temperature and relative humidity are used to obtain data from the environment. Zoom inspection optics read gauges and position indicators, can inspect for leaks or cracks. Noise sensors monitor equipment and system performance.

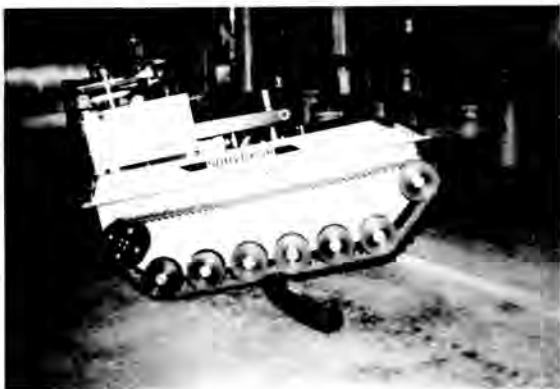
Fig. 2. Surveyor™ Surmounting the 4-inch Diameter Steel Pipe.

Moving at speeds up to 1 foot/second, the Surveyor™ robotic vehicle is designed to traverse obstacles, wade through water up to fourteen inches deep, climb 40-degree stairs, maneuver through doors, halls, and labyrinth entries, and requires less than a 34-inch vertical clearance. Figures 2 and 3 illustrate action photographs of Surveyor™ surmounting steel pipe and wooden pallet. The unique modular design incorporates basic building blocks which can be reconfigured for a variety of applications. These building blocks include:

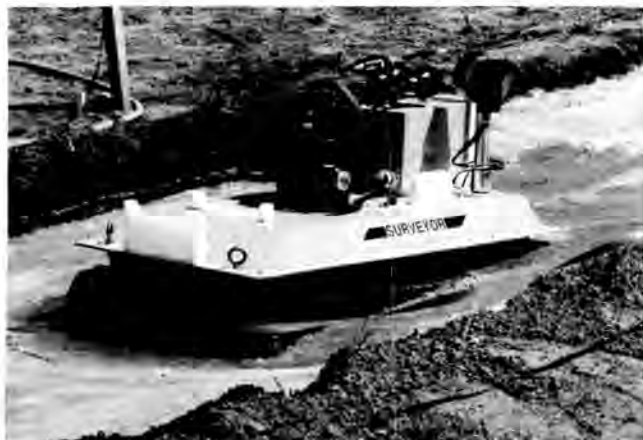
Fig. 4. Surveyor™ Traversing through Mud Pool.

On June 2nd there was a demonstration of Surveyor™ for the television and printed media. This was covered by local and national TV news and newspapers. On June 3rd, Surveyor™ was tested for a large Nine Mile Point audience at a "mud run" which was designed to simulate conditions of deep water and sludge (Fig. 4). This demonstration was successful and the outdoor facilities were to be used to train three operators to support the radwaste project. The plans were unfortunately interrupted the next day by an explosion within Surveyor™.
